Three-dimensional subsurface defect shape reconstruction and visualisation by pulsed thermography

Adisorn Sirikham^a, Yifan Zhao^{a,*}, Haochen Liu^a, Yigeng Xu^a, Stewart Williams^a, Jörn Mehnert^b

^a School of Aerospace, Transport and Manufacturing, Cranfield University, Cranfield, MK43 0AL, UK

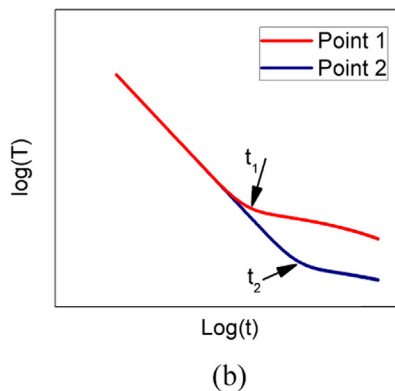
Fig. 1. (a) Experimental configuration of the pulsed thermographic inspection under the reflection mode, where point 1 denotes a surface location with a defect underneath and point 2 denotes a location on the sample surface with no defect underneath; (b) Typical observed time-temperature decay curves in the logarithmic domain for the point 1 and 2, respectively, where the time of t_1 and t_2 is the key to measure the thickness of local materials [7].

In a pulsed thermographic inspection in reflection mode, a short and high energy light pulse is projected onto the sample surface through one or two flash lamps (see Fig. 1(a) for typical experimental setup) [33].

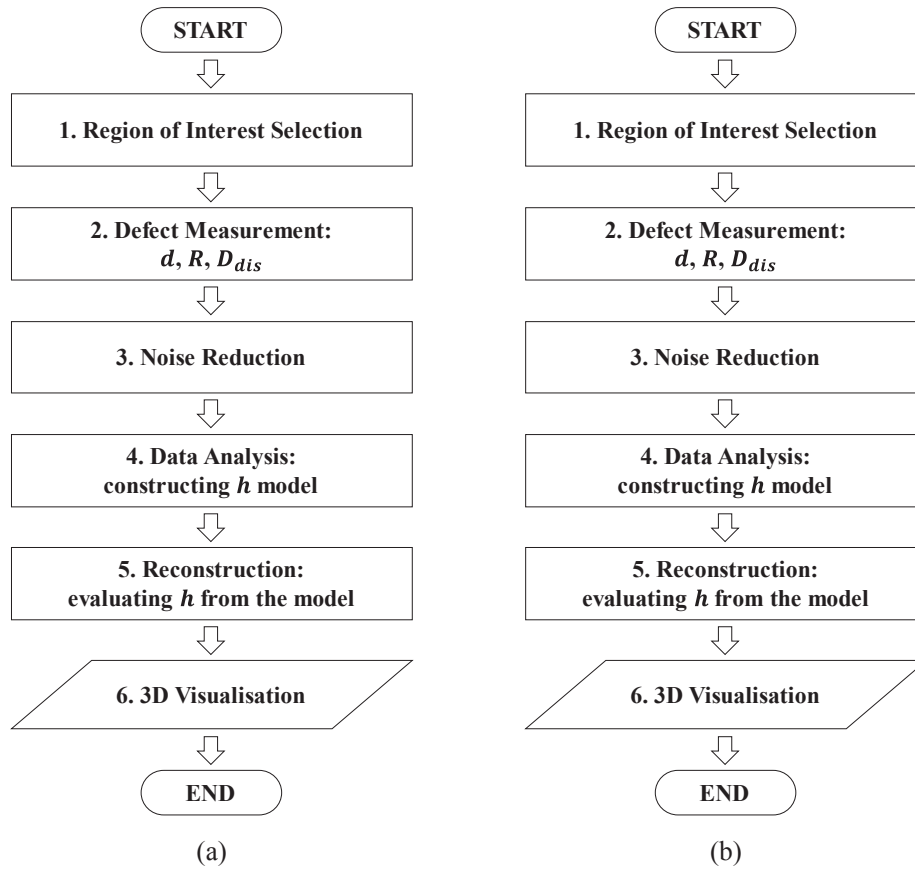
Fig. 3. Inspection process for (a) the single-side inspection and (b) the double-side inspection.

The single-side inspection and the double-side inspection can be described in the flowcharts as shown in Fig. 3. For the single-side inspection, the first step is to select the region of interest (ROI), which aims to select a region for defect estimation and visualisation to reduce overall processing time. The ROI was selected manually in this paper. The second step is defect measurement to obtain subsurface

information of ROI including defect depth (d), the shortest distance from the boundary of the defect to the inspecting point (D_{dis}), and thermal wave reflection coefficient of the defect (R), which are achieved by the NLSF method. The third step is noise reduction to enhance image quality (R image and d image), which is achieved by the application of a Median Filter [35] in this paper. The fourth step is to establish the relationship model between h , R , and D_{dis} , shown in Eq. (3), based on the estimated parameters in the second step. The fifth step is to estimate the defect thickness based on the established model. The last step is to visualise the defect in the form of a 3D image, where the reconstructed defect (size, depth, thickness, and location of the defect) is fused with the dimension (width, length and thickness) of the sample to produce a volume image. This volume image is then rendered and displayed in the form of a 3D image. For the double-side inspection, most steps are similar to the single-side inspection except the second, the fourth, and the fifth step. In the second step, the sample's thickness and defect depth of the both side of the sample are required, whilst the defect depth from the single-side inspection requires one side only. The fourth step is to align the position of the defect region between the front side and the back side and the fifth step is to estimate the defect thickness from Eq. (8).

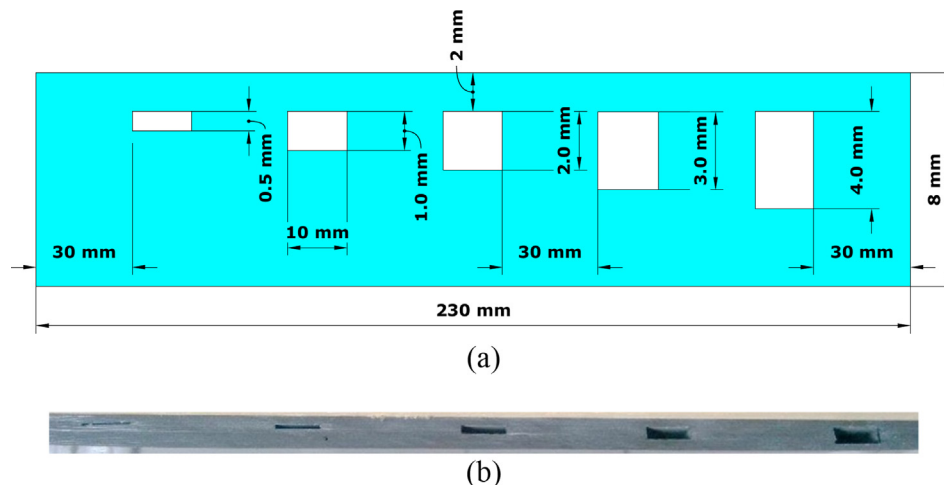
Fig. 4. Illustration of Sample 1 (a) Sample design (b) Side view.

A flat plate of carbon fibre reinforced polymer (CFRP) material was used in this study. The plate was made of unidirectional Toray 800 carbon fibres pre-impregnated with Hexcel M21 epoxy resin and manufactured in a traditional autoclaving process. The dimension of Sample 1 is 75 mm \times 230 mm \times 8 mm. As illustrated by Fig. 4(a), it includes five block defects with a thickness (h) of 0.5 mm, 1.0 mm, 2.0 mm, 3.0 mm, and 4.0 mm, respectively, named Defect1 to Defect5. The width (r), length, and depth (d) for all defects are 10 mm, 75 mm, and 2 mm respectively. The distance between two adjacent defects is 30 mm, which aims to reduce the influence from the adjacent defects on the thermal behaviour. A side view of the produced sample is shown in Fig. 4(b). It should be noted that these defects are not fully closed because two sides of the defects are open. This sample is aimed at studying the relationship between R , h , and D_{dis} when d is fixed.

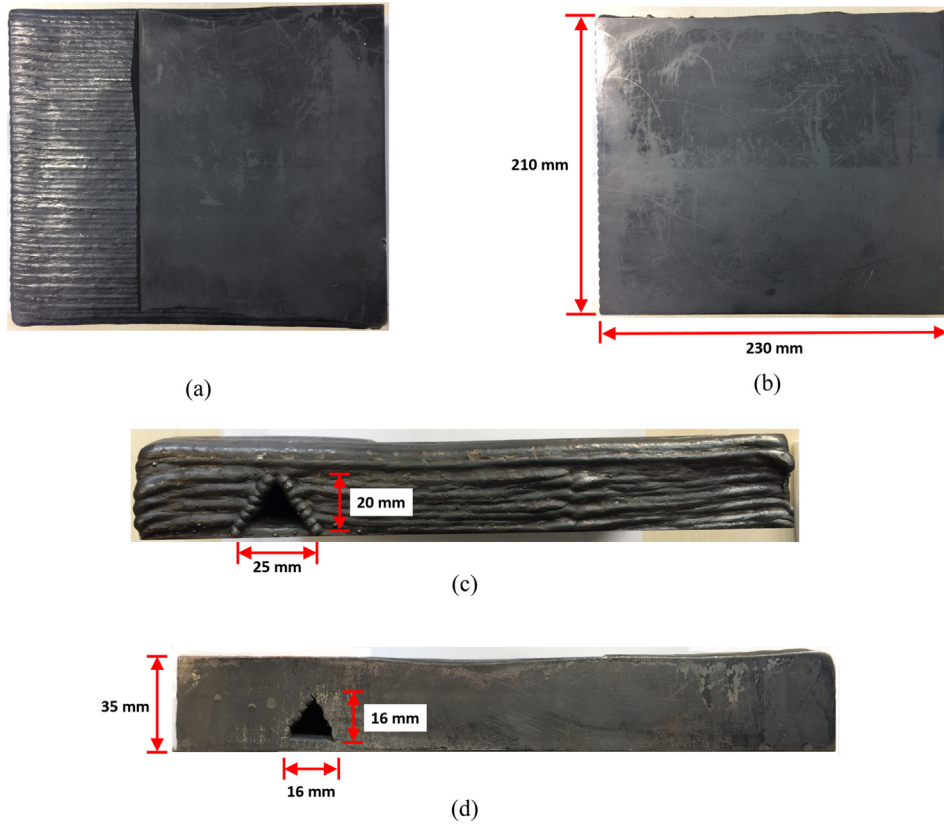
Fig. 5. Snapshots of Sample 2: a steel plate with triangle air-gap defects (a) the back side of the sample (b) the front side of the sample and inspected side (c) the top side of the sample (d) the bottom side of the sample.

As a use case, Sample 2 was made from steel with a dimension of 210 mm \times 240 mm \times 35 mm, as shown in Fig. 5. There is an 'S' shape triangular air-gap through the sample. By measurement, at the top side of the sample, the defect is estimated to be triangular in shape, which has the base about 25 mm and the maximal thickness about 20 mm, illustrated in Fig. 5(c). At the bottom side of the sample, the defect is also estimated to be triangular in shape, which has the base about 16 mm and the maximal thickness about 16 mm, illustrated in Fig. 5(d). The sample was inspected at the flat side using the proposed single-side thermographic inspection, illustrated as Fig. 5(b).

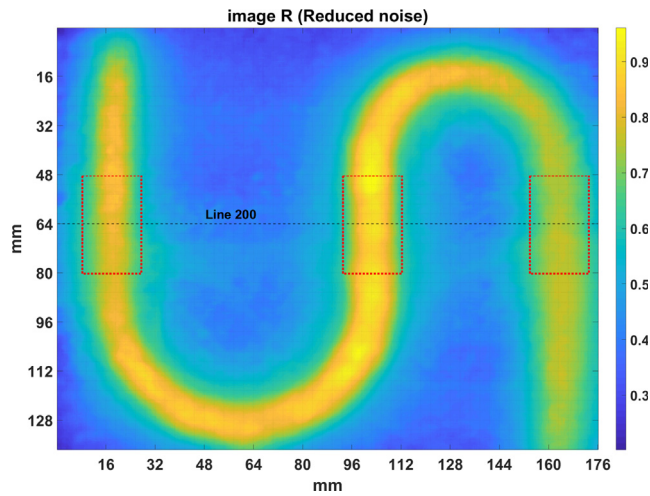
Fig. 12. The averaged R region over the top side triangle defect area for Sample 2.

Sample 2 was inspected by the single-side inspection because the defect was too deep to measure from the other side. To find the relationship between R and h , R values in three areas with a size of

100×60 pixels were sampled as highlighted in Fig. 12. It should be pointed out that the R values of 100 vertical pixels were averaged. Fig. 13 plots the cross-section at line 200 of the estimated R and d , where the three selected areas are highlighted. It can be observed that the middle area has the highest value of R , then the left one and the right now. Proven in the experiments of Sample 1, a higher value of R suggests a thicker defect. As illustrated in Fig. 5, the maximal thickness of the left defect is about 20 mm, and the right one is about 16 mm. Based on the observation of the R values, the maximum thickness of the middle area is assumed to be 24 mm. A numerical model was then established to represent the relationship between R and h , written as

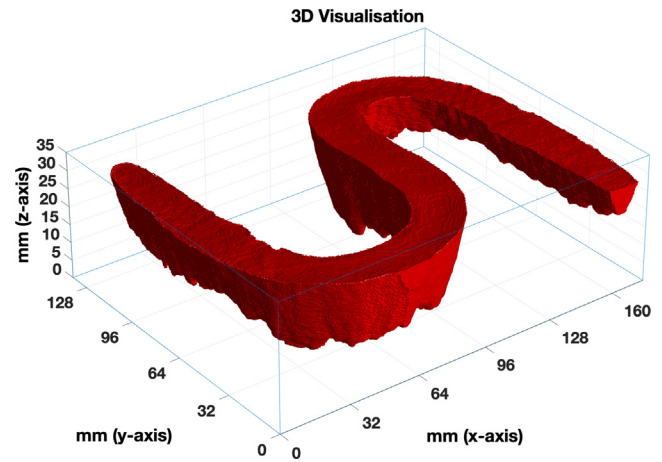
Fig. 14. 3D defect visualisation of Sample 2 defects using the proposed single-side inspection.

As the last step, the 3D volume image was reconstructed by combining the surface dimension (size and thickness of the sample) and subsurface information (defect depth and defect thickness) and result is shown in Fig. 14. The triangular 'S' shape defect can be clearly observed which matches the appearance of the defect shown in in Fig. 5(c) and Fig. 5(d). To validate the result using other NDT methods, Fig. 15 shows the comparison of the 2D image of the defect from pulsed thermography and X-ray. It can be seen that the defect shape of both images is similar. A quantitative comparison between these two imaging modalities in terms of 3D defect reconstruction was not conducted in this paper due to the distortion of thermal images caused by the lens. A further study is required to correct this distortion before conducting a comprehensive comparison.
